SPRAY POLYURETHANE FOAM

The Roofing System That Can Stand Up To High-Wind Disasters

Spray polyurethane foam roof resists wind uplift

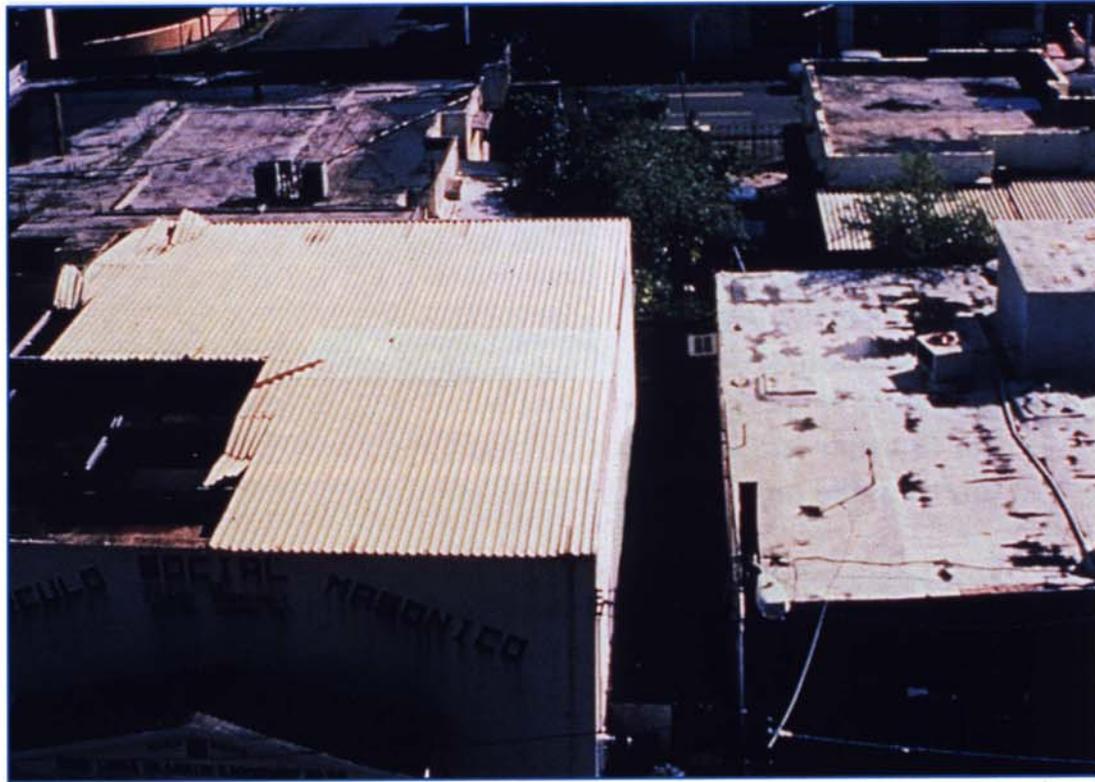
These two buildings in Puerto Rico are located just a few yards apart, so they both received the same degree of wind force when Hurricane Hugo stormed over the island. The building on the left received major damage as wind uplift ripped off a portion of the roof.

The building on the right has a spray polyurethane foam roof which held tight. There was no peeling, penetration or water leakage.

Polyurethane foam is self-flashing – it forms a seal that grips the building wall and roof-mounted equipment so there are no edges for the wind to lift up and peel away.

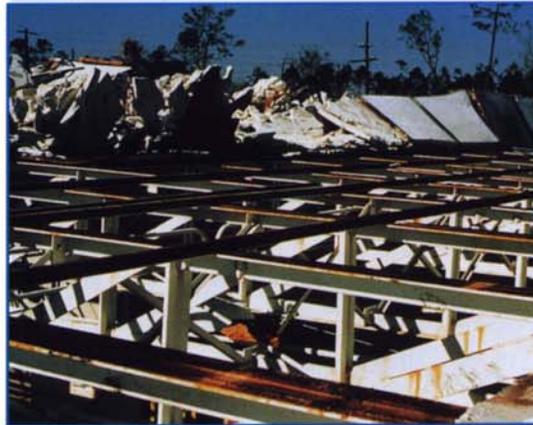
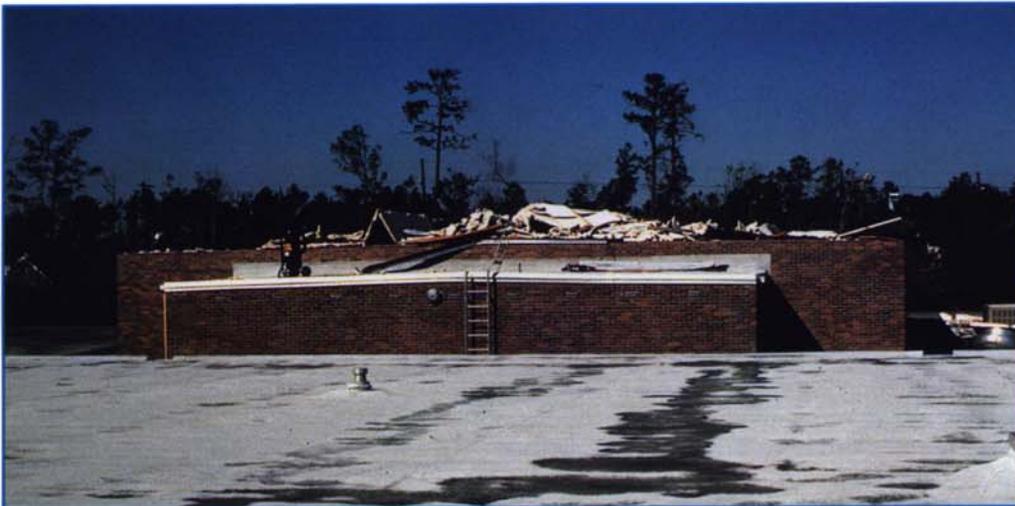
This is the scene after Hurricane Hugo whipped through a school campus in Charleston, S.C. The gymnasium in the background had a cement-wood fiber deck. Hugo pulled it up and blew away most of the roof. Debris, rain and high winds ravaged the inside of the building.

The deck you see in the photo below is a spray polyurethane foam roof on the main school building. It sustained only minor damage from flying debris and was easily repaired. There was no water leakage or collapse.

The photo below shows a close-up of Hugo's destruction to the cement-wood fiber deck of the school gymnasium. This roof was damaged beyond repair.

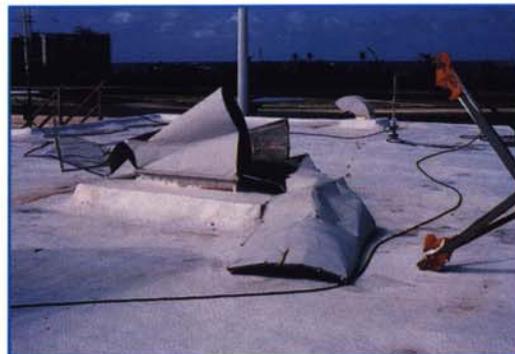
Hurricane Hugo crumpled the metal attachment on top of the American Airlines terminal in Puerto Rico. A communications dish was ripped from its mountings (right), but the spray polyurethane foam roof remained fully intact.

Another terminal 150 yards away had a EPDM roof which gave way to Hugo's heavy hand. The building's interior was exposed to the elements and saturated with water, requiring thousands of dollars in repairs.

Spray polyurethane foam roofing protected the American Airlines terminal from major damage and enabled it to stay in business.

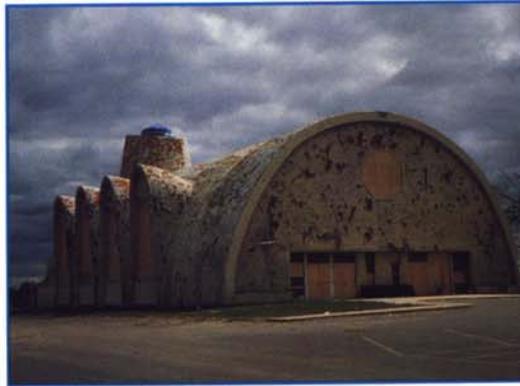
This church survived the tornado that cut a path of destruction through Plainfield, Illinois. The building was completely covered in spray polyurethane foam. There was repairable missile damage to the exterior surface, yet the sealed spray polyurethane foam helped to strengthen the building and resist uplift from the high-force winds. Because polyurethane foam is spray-applied, it can conform to any shape and provide a sealed envelope of protection.
